URGENT MEDICAL DEVICE CORRECTION

FOR A SUBSET OF GALLANT™, NEUTRINO™,
AND ENTRANT™ ICDs AND CRT-Ds
MANUFACTURED PRIOR TO APRIL 2022

MODELS CDVRA500Q, CDDRA500Q, CDHFA500Q, CDVRA600Q,
CDDRA600Q, CDHFA600Q, CDVRA300Q, CDDRA300Q, AND CDHFA300Q

August 2023

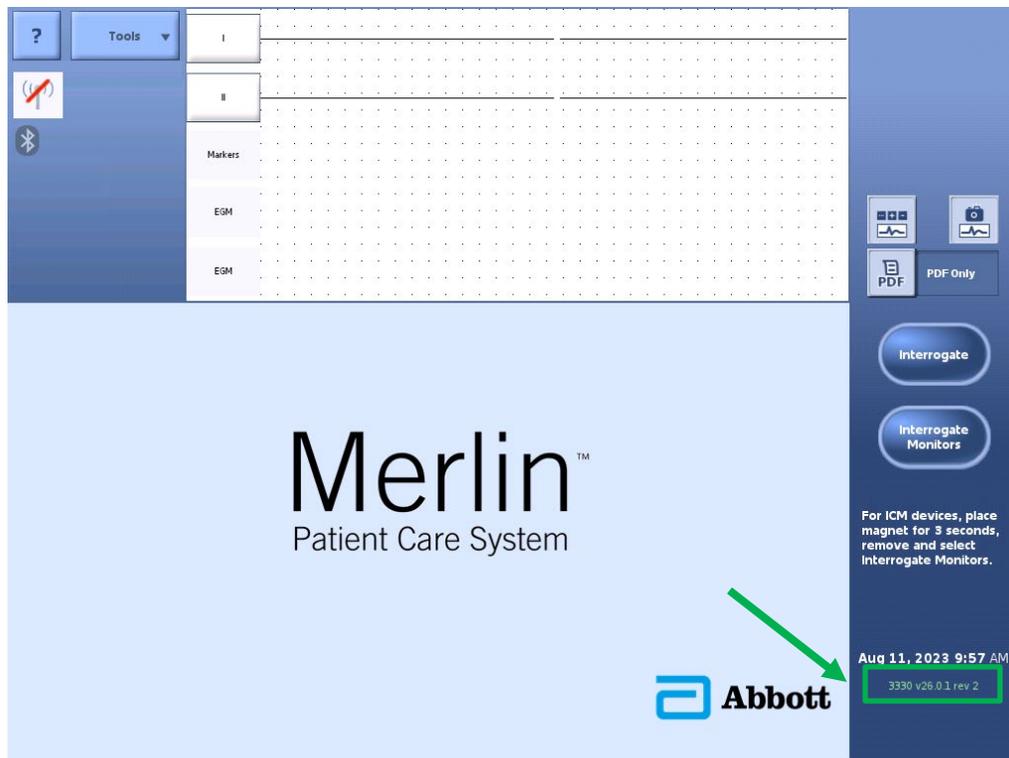
Image 2: Merlin™ PCS 3650 software version visible on the startup screen

The Merlin™ PCS 3650 software version is visible on the lower right corner of the initial startup screen, as displayed in the image below. Confirm the programmer software version is 3330 v25.4.x or higher.
